Debris/Ice/TPS Assessment and Integrated Photographic Analysis of Shuttle Mission STS-75

Technical Memorandum 111472

April 1996

22 February 1996

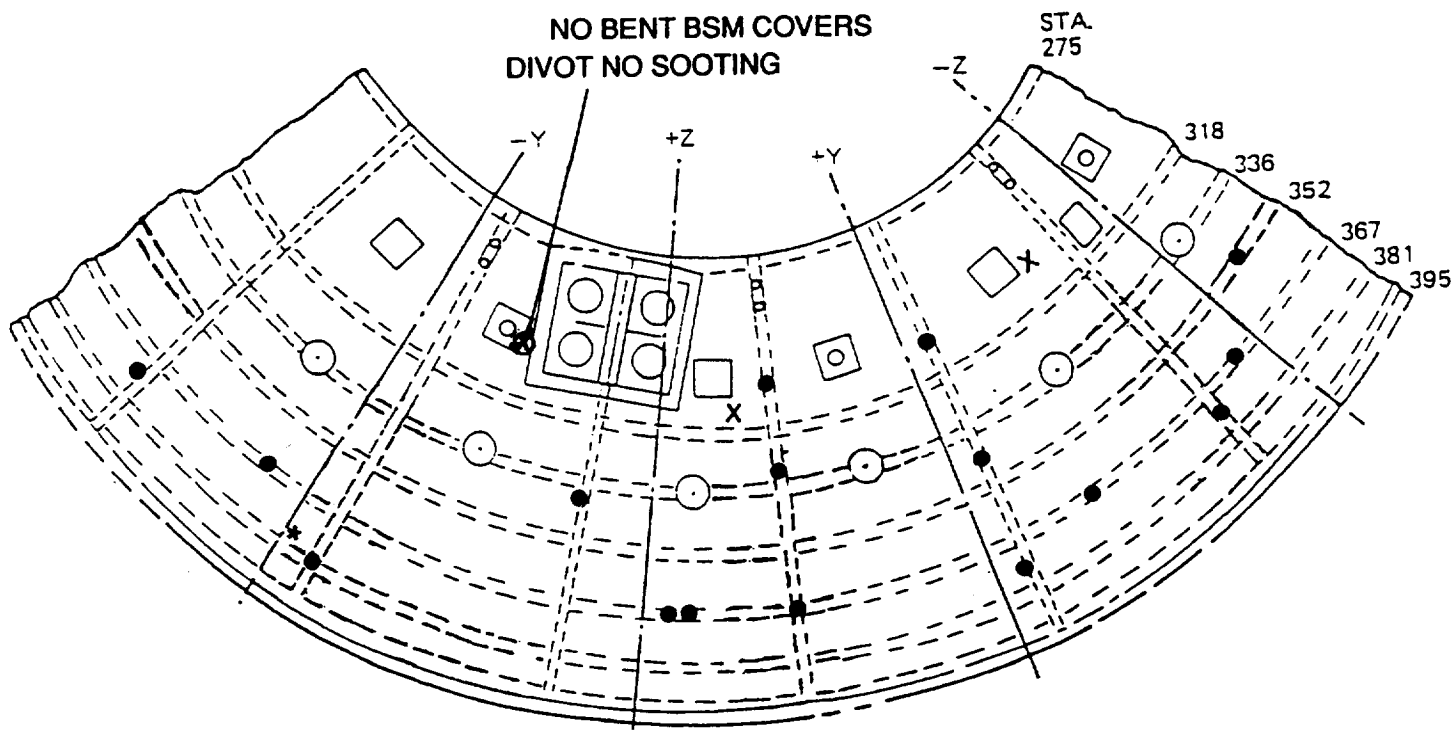
Figure 1: RH SRB Frustum

The RH frustum was missing no TPS. The number of debonds over fasteners (16) and over acreage (2) was less than average (Figure 1). Hypalon paint was blistered/missing along the XB-395 ring frame where BTA closeouts had been applied. However, most of the exposed BTA substrate was not sooted. The BSM aero heat shield covers had locked in the fully opened position.

DEBONDS
● 16 FASTENER
x 2 ACREAGE
* DEBRIS IMPACT

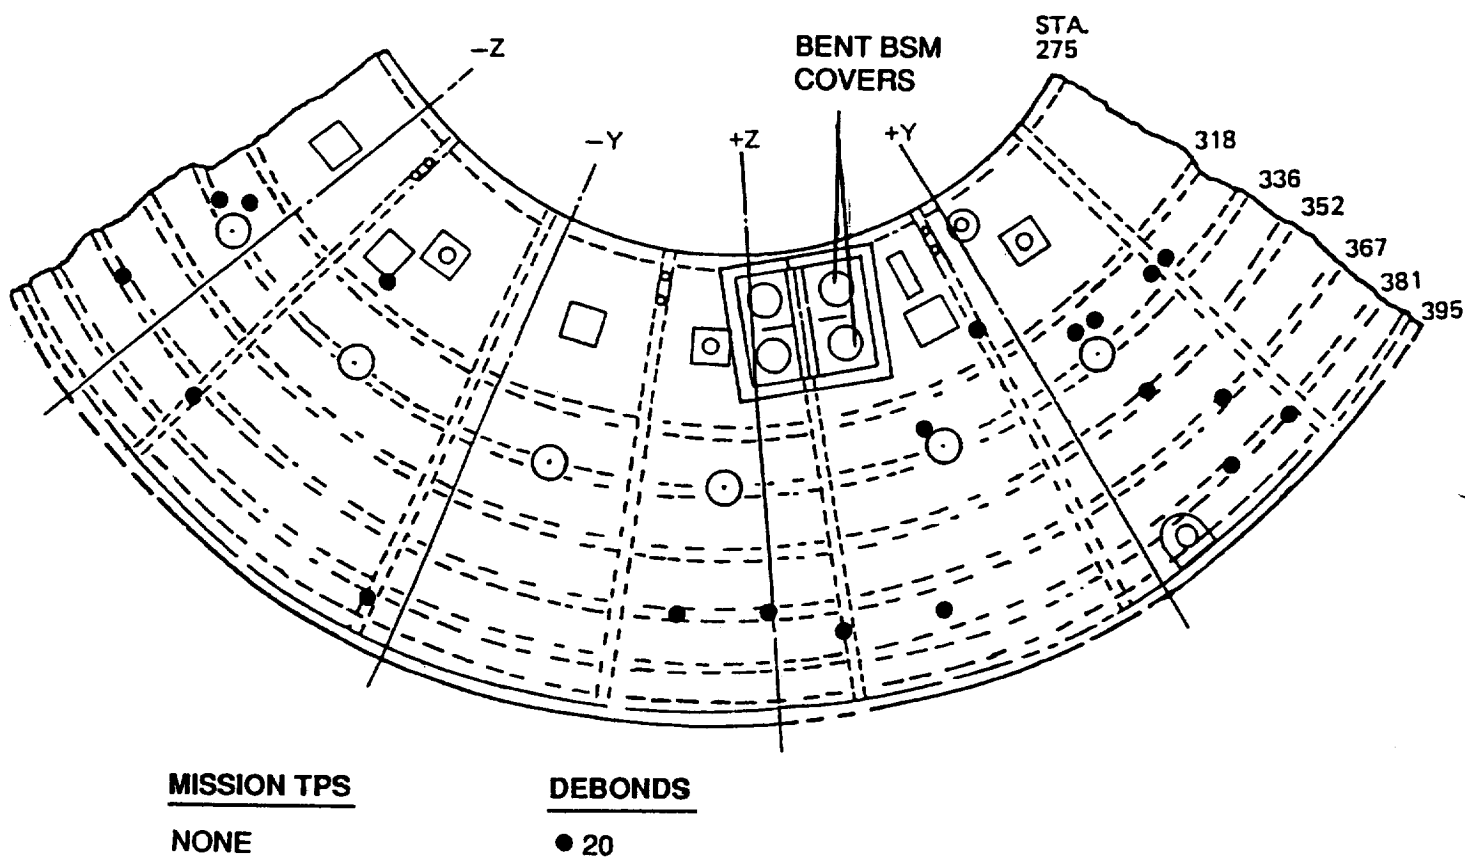
Figure 2: LH SRB Frustum

The LH frustum was missing no TPS. The number of MSA-2 debonds over fasteners (20) was less than average (figure 2). Hypalon paint was blistered/missing along the XB-395 ring frame where BTA closeouts had been applied. However, most of the exposed BTA substrate was not sooted. The BSM aero heat shield covers had locked in the fully opened position though the two right cover attach rings had been bent by parachute riser entanglement after splashdown.

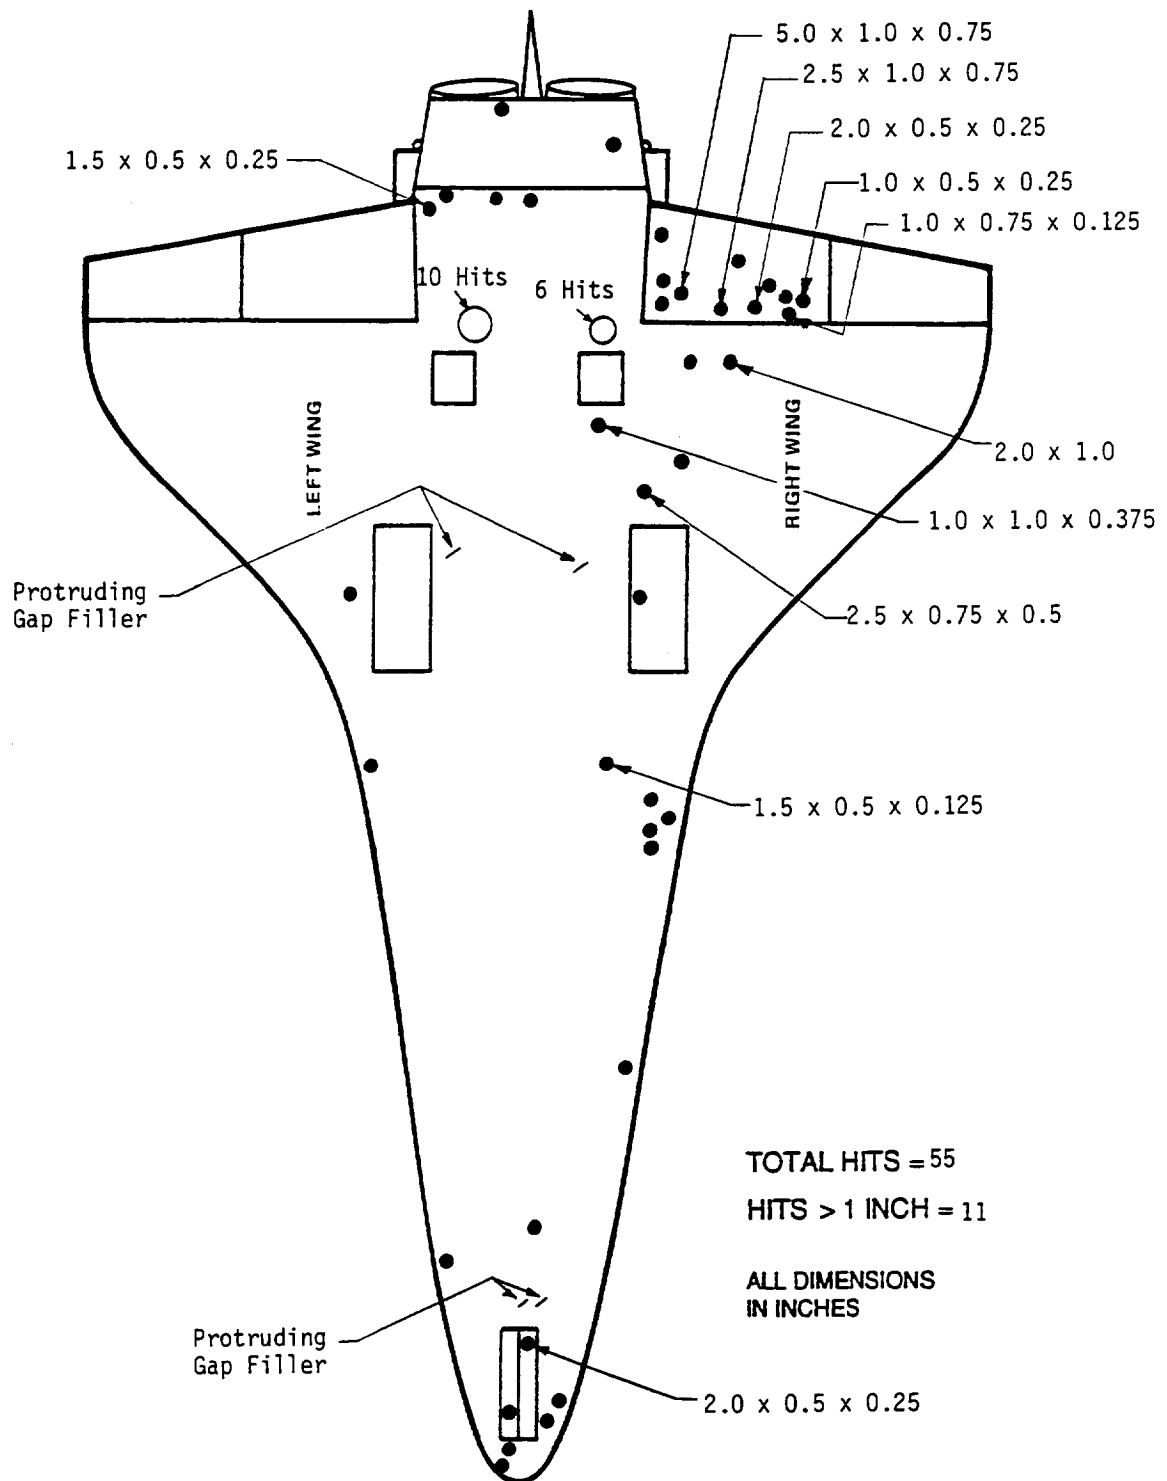
Figure 3: Orbiter Lower Surface Debris Map

The Orbiter lower surface sustained a total of 55 hits, of which 11 had a major dimension of 1-inch or larger. The largest lower surface tile damage site occurred on the right inboard elevon and measured 5.0-inches long by 1.0-inch wide by 0.75-inch maximum depth. Hits on the right side along a line from nose to tail are generally attributed to ice impacts from the ET LO2 feedline bellows and support brackets.

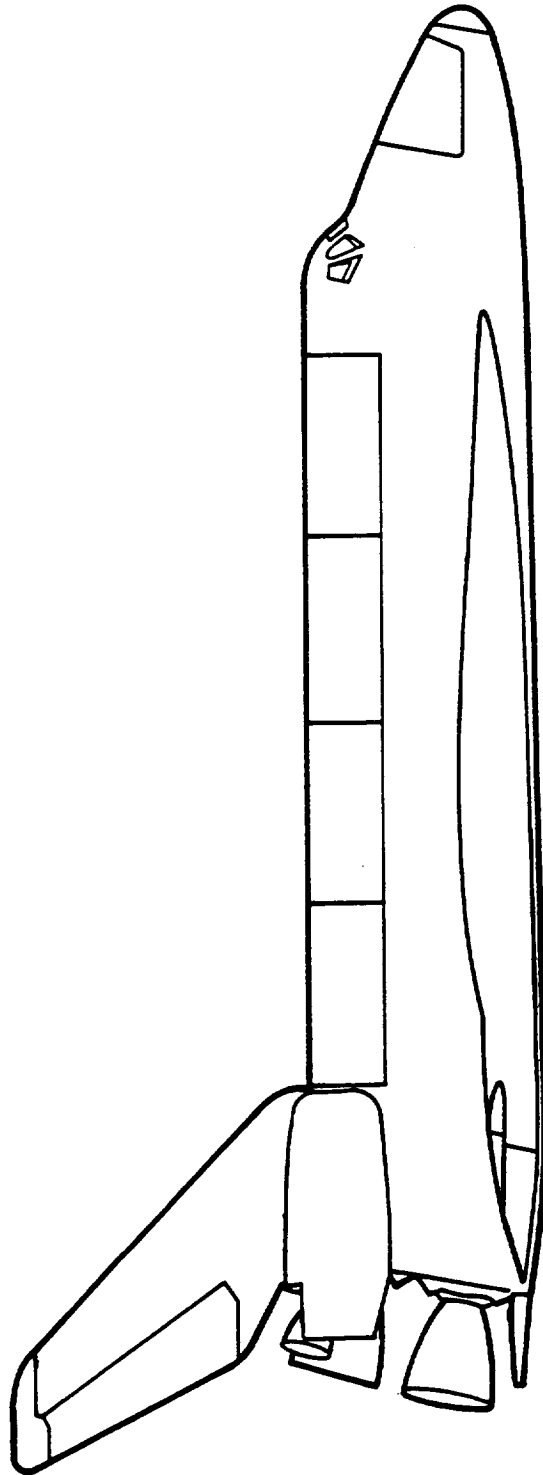
Figure 5: Orbiter Right Side Debris Map

TOTAL HITS = 0
HITS > 1 INCH = 0

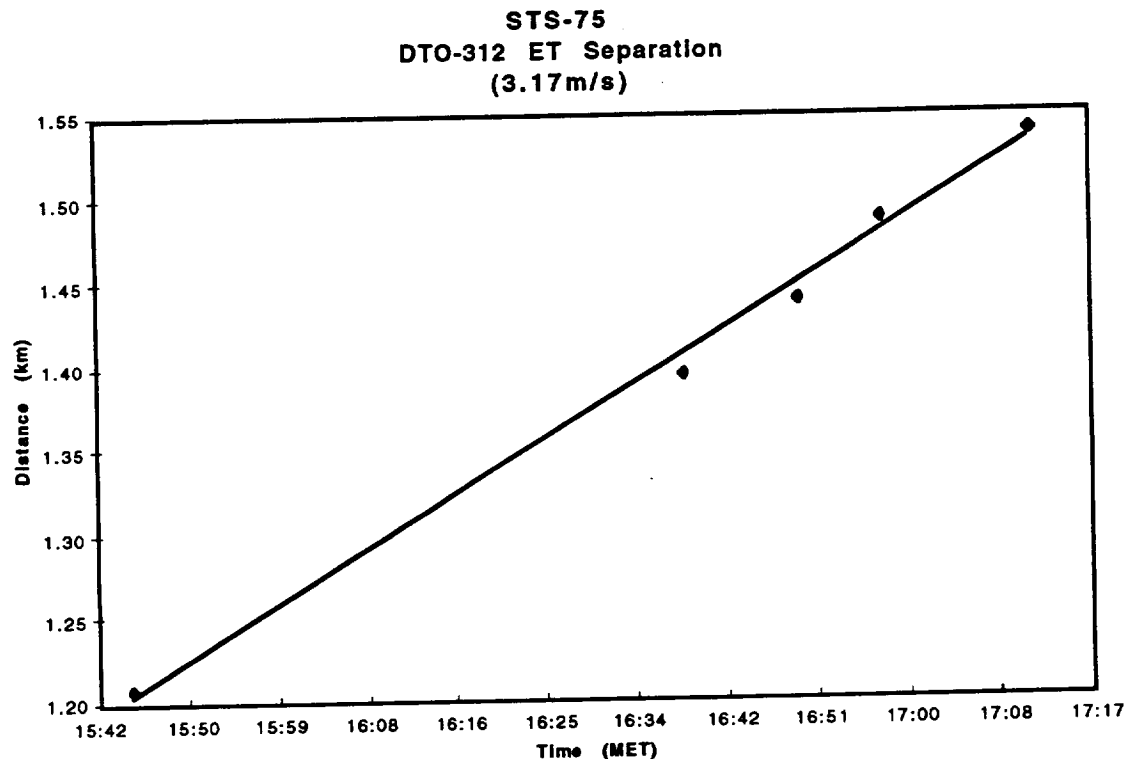
Figure 2.4.1 (A) ET Separation Velocity

Using the 35 mm handheld (Nikon F4) camera film, the external tank distance was calculated over a 5 frame sequence. The external tank was calculated to be a distance of 1.21km away from the Orbiter at 15:45 MET; 86 seconds later at 17:11 MET the tank was calculated to be at a distance of 1.54km. The tank separation velocity was determined to be 3.17 m/s. Roll rate was estimated at 0.1°/sec, and tumble rate was estimated at 0.03°/sec. The separation velocity and roll/tumble rates were similar to previous mission measurements.

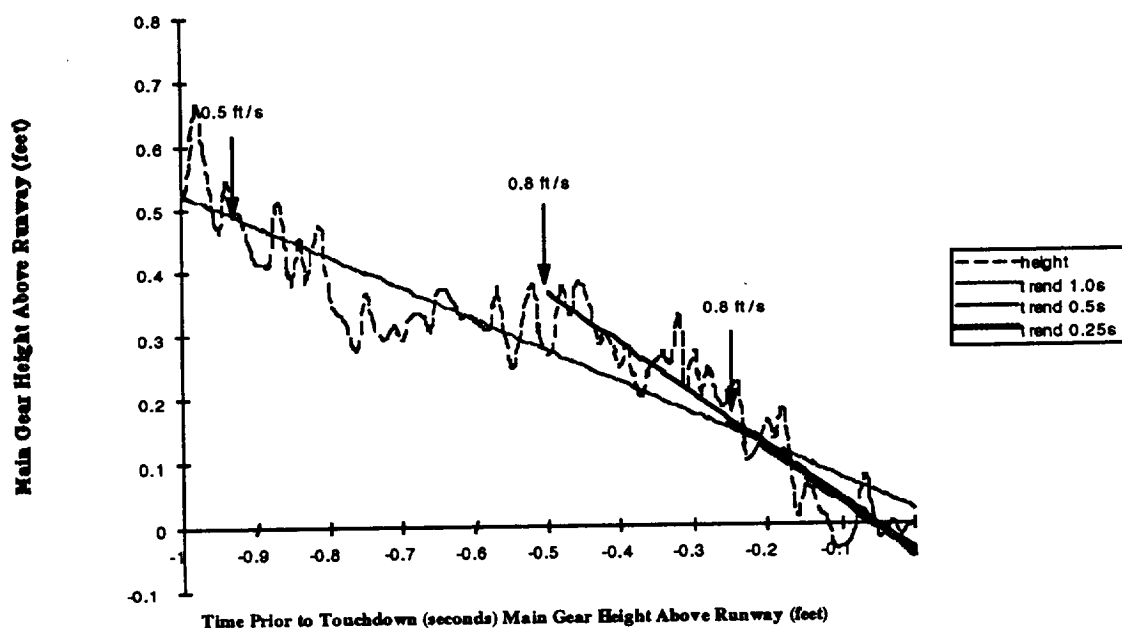
The measured main gear values were found to be below the maximum allowable values of 9.6 ft/sec for a 211,000 lb. vehicle and 6.0 ft/sec for a 240,000 lb. vehicle (the landing weight of the STS-75 Orbiter was reported to be 228,500 lb.). The sink rate measurements for STS-75 are given in Table 2.5.1. In Figure 2.5.1 the trend of the measured data points for film image data are illustrated.

Figure 2.5.1 Main Gear Height Versus Time Prior to Touchdown (Film)
